# Corrosion

**Notch Sensitivity Effects in Stress Corrosion  
and Hydrogen Embrittlement Tests on  
High Strength Steels . . . . . 17**

**Internal Cathodic Protection of  
Large Pipes Carrying Sea Water . . . . . 35**

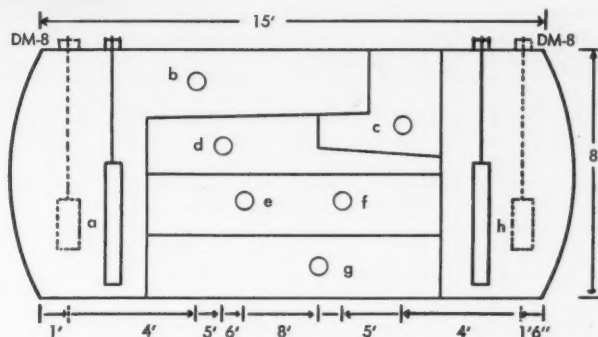
This drawing depicts anode placement for both magnesium and graphite.

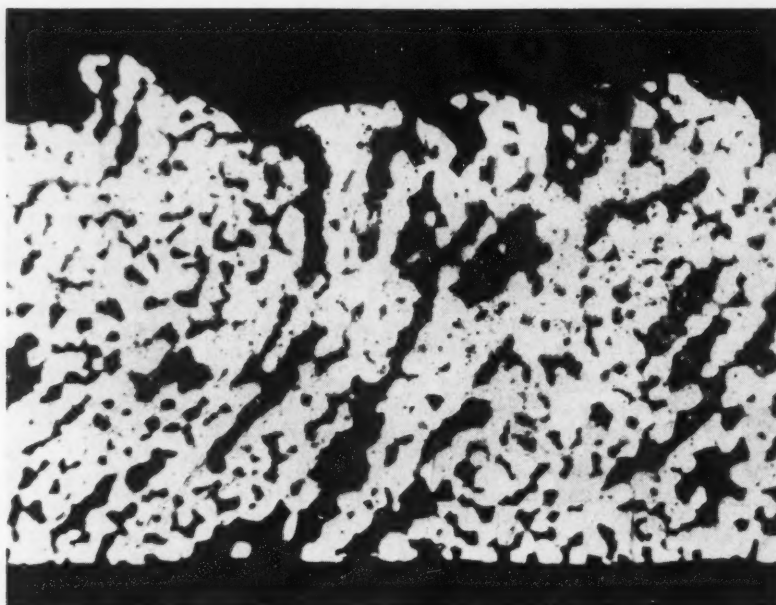
Figure 1—Microstructure of 50:50 tin-lead solder corroded by 20 percent sodium benzoate solution. Corrosion has taken place preferentially in the lead-rich  $\alpha$  phase.

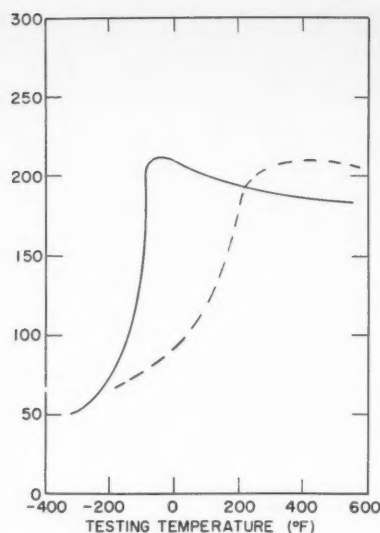
Figure 1—Effect of temperature on the net fracture stress of modified Type 422 steel tempered at 900 F (broken curve) and 1050 F (continuous curve). Center-cracked strip specimens were 0.040-inch thick. (From Reference 2.)

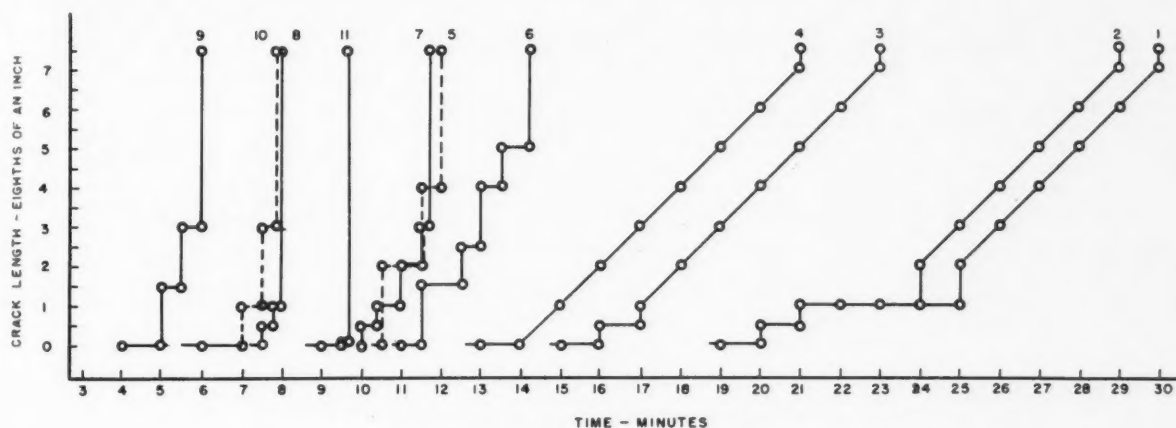
Figure 5—Crack propagation in bent strip specimens at various stress levels immersed in corrosive.

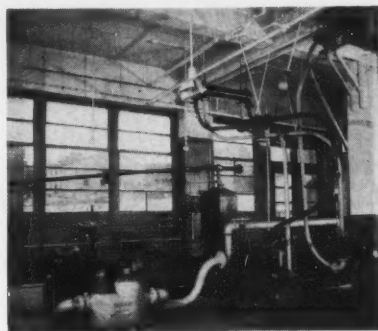
Figure 6—Photo of the cooling system experiment.

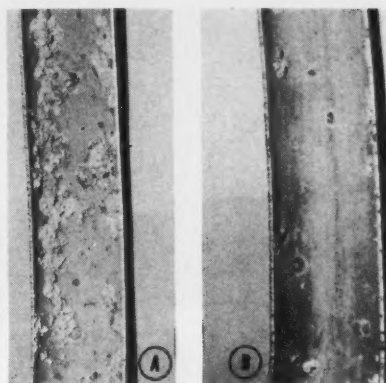
Figure 7—Cross sections of clad aluminum tubing used in minesweeper cooling system. Section A was located 3 feet from copper-base main circulating pump; Section B was 10 feet from pump. No complete penetration was found, but the attack was heaviest near the copper-base alloys.

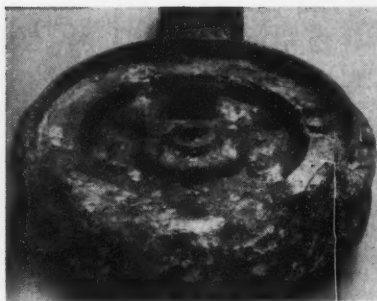
Figure 8—Corroded valve of the wedge pattern. Failure was attributed to galvanic attack caused by the unfavorable ratio of aluminum to stainless steel used in the valves. Stainless steel side plates are not shown.

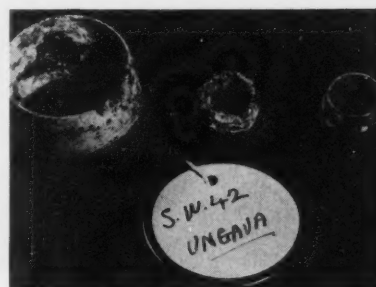
Figure 11—Corrosion of aluminum ferrules.

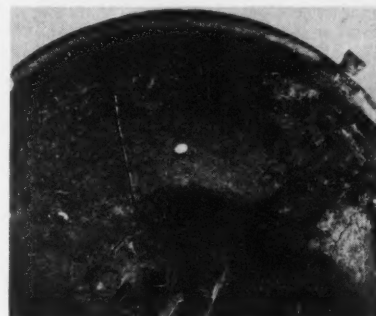
Figure 12—Stress corrosion failure of sanitary pump cover made of aluminum alloy 220. Amount of magnesium in this alloy was considered critical.

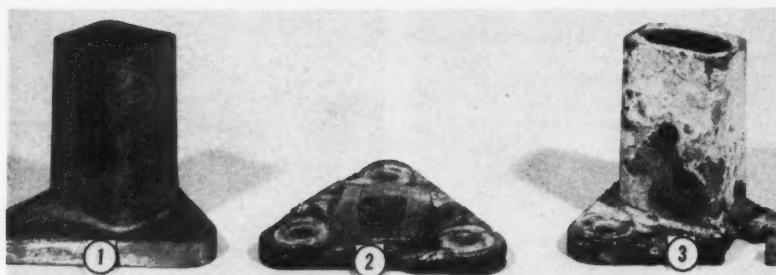
Figure 13—Stanchion sockets made of aluminum alloy 220. Number 1 is a new socket; Numbers 2 and 3 are failed components.

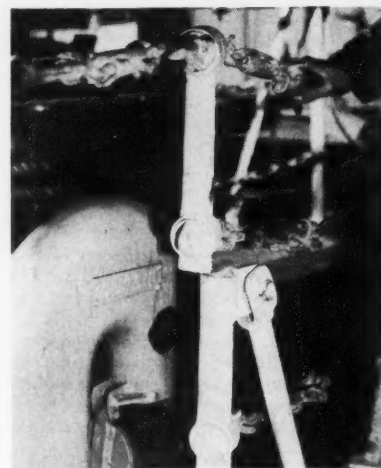
Figure 14—Failure of cast aluminum stanchion.

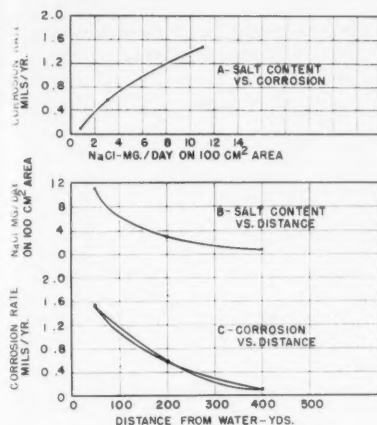
Figure 2—Corrosion rate of zinc vs. distance from shore and salt content of air.

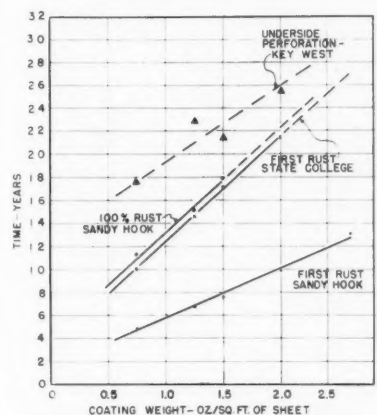
Figure 3—Time to failure vs. coating weight.

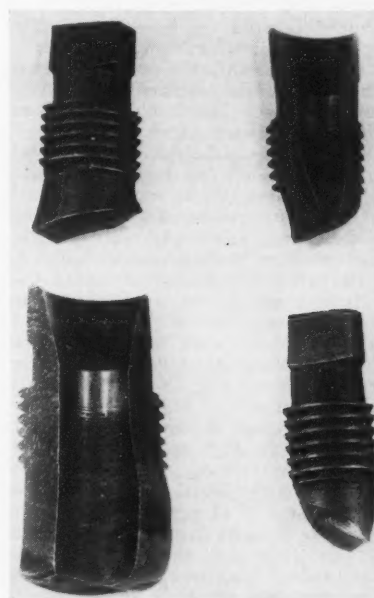
Figure 2—Typical failure of wellhead chokes and valves.

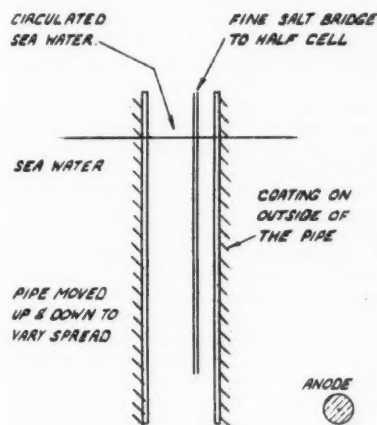
Figure 5—Laboratory test arrangement.

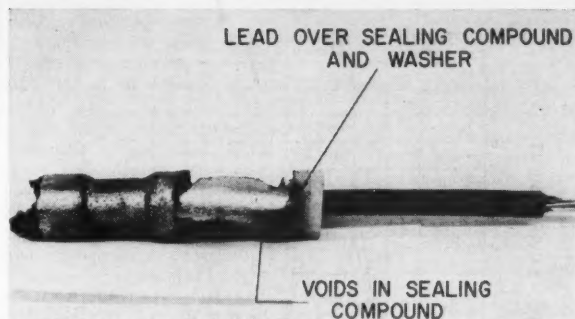
Figure 6—Internal connection and seals of silicon iron anode tested.

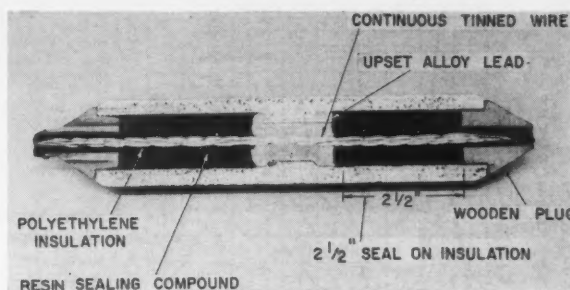
Figure 7—Improved silicon iron anode element.

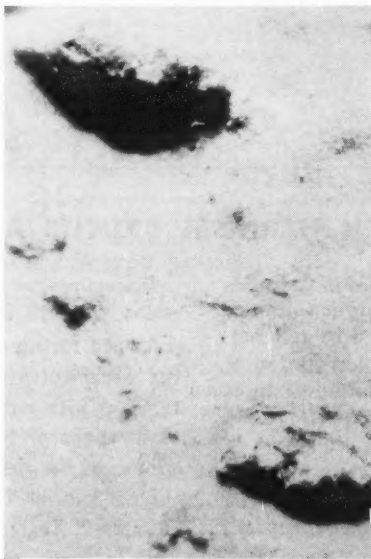
Figure 1—Rusting on tips of painted peaks.

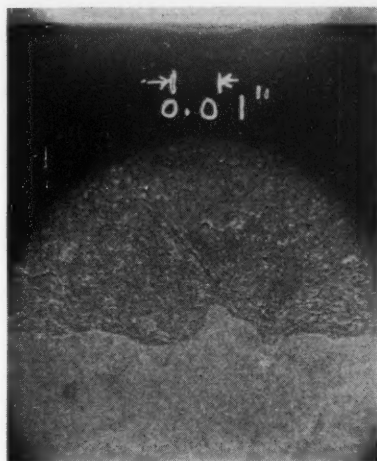
Figure 4—Cross section of G16 grit blasted steel.

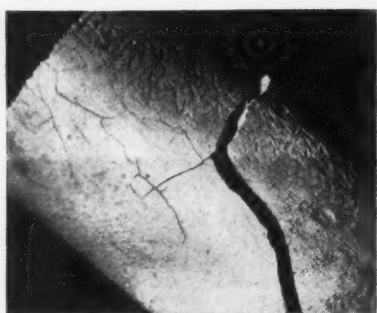
Figure 1—Red-brass pipe. Note cracks in outer surface. 1.8X.

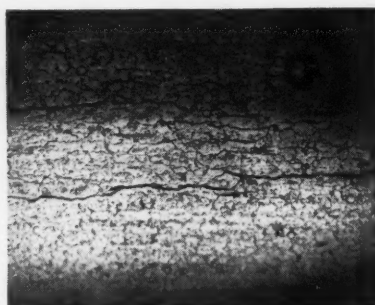
Figure 3—Phosphorized copper tube. Cracks are shown in outer surface.

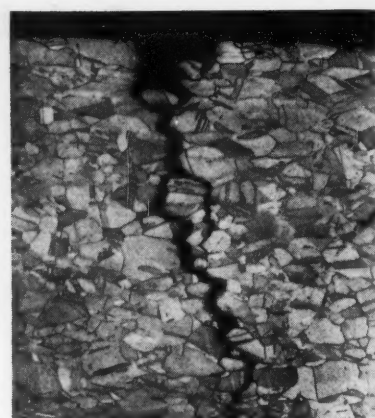
Figure 4—Longitudinal section through crack in phosphorized copper tube. 100X.

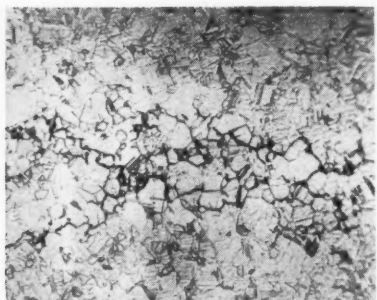
Figure 2—Longitudinal section through intergranular crack in red-brass pipe. 125X.

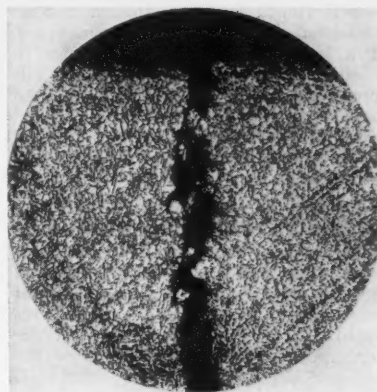
Figure 5—Cross section through crack in cupro-nickel-30 percent tube. 50X.

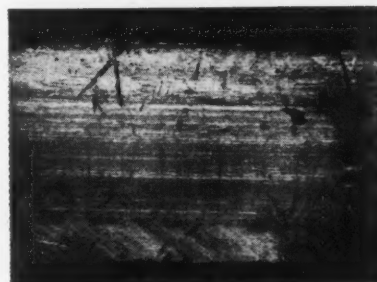
Figure 6—Naval brass painters' trolley. 4X.

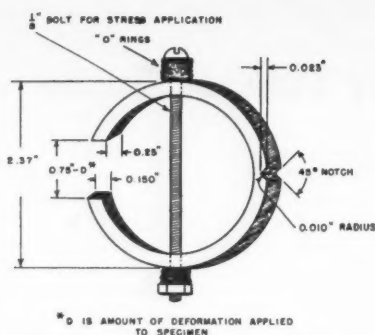
Figure 1—Notched rings used in studies of stress corrosion cracking. This specimen has shown that cracking failures do occur at below yield loads when notches are present.

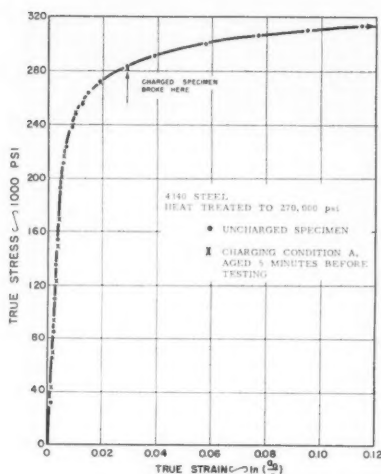
Figure 3—Initial portion of true stress—true strain curve for A1514340 specimens charged with hydrogen and uncharged with hydrogen. Artificial cathodic charging was used.<sup>10</sup>

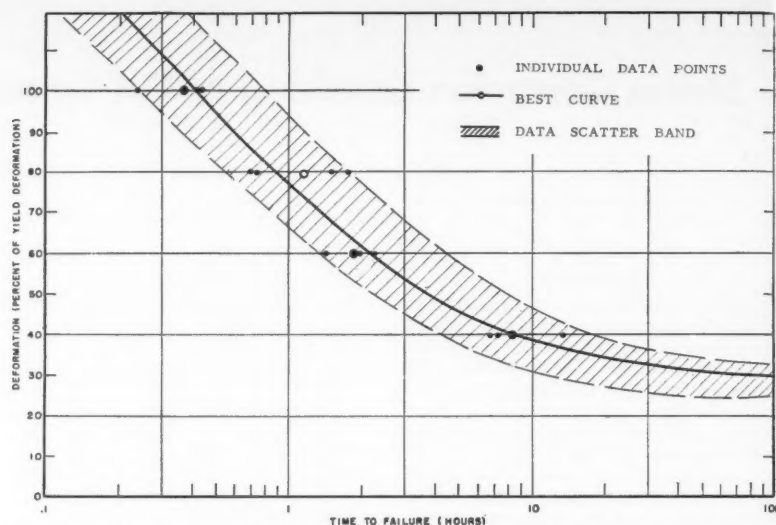
Figure 2—Time-to-failure data obtained on N-80 material, oil quenched and tempered to approximately Rockwell C 33-35 hardness, deformed to different percentages of the C-ring yield deformation and exposed to H<sub>2</sub>S saturated (3000 ppm) 5 percent NaCl.

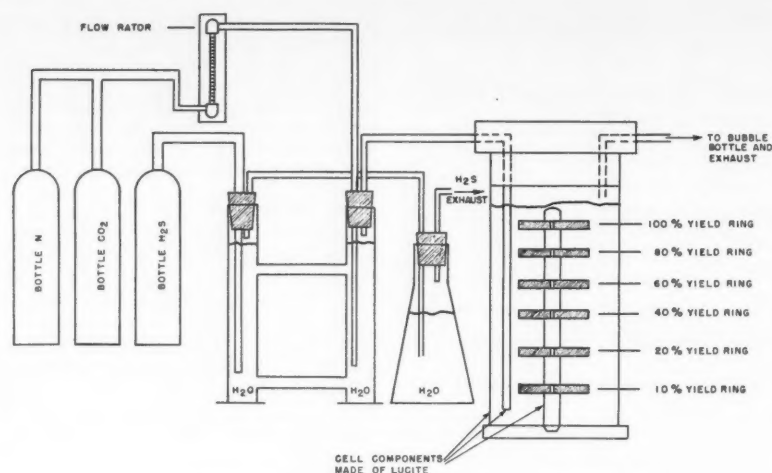
Figure 5—Laboratory set-up for conducting low H<sub>2</sub>S concentration cracking tests.

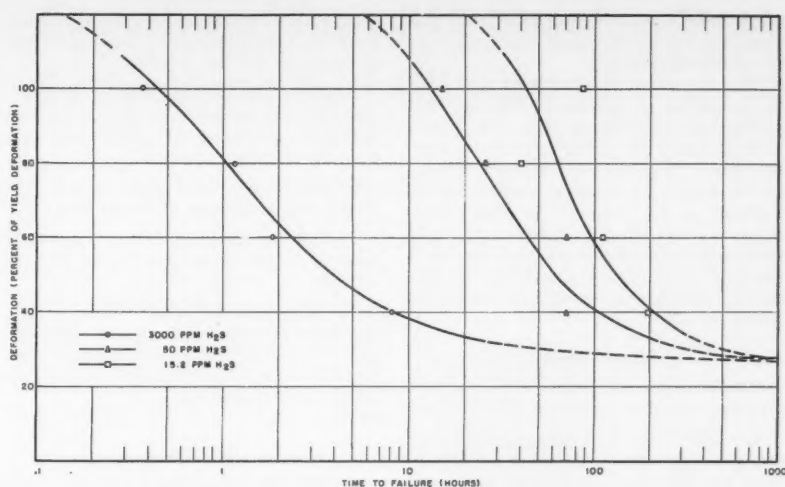
Figure 6—Time-to-failure data obtained on N-80 material, oil quenched and tempered to approximately RC 33-35 hardness in solutions containing different concentrations of dissolved  $\text{H}_2\text{S}$ .

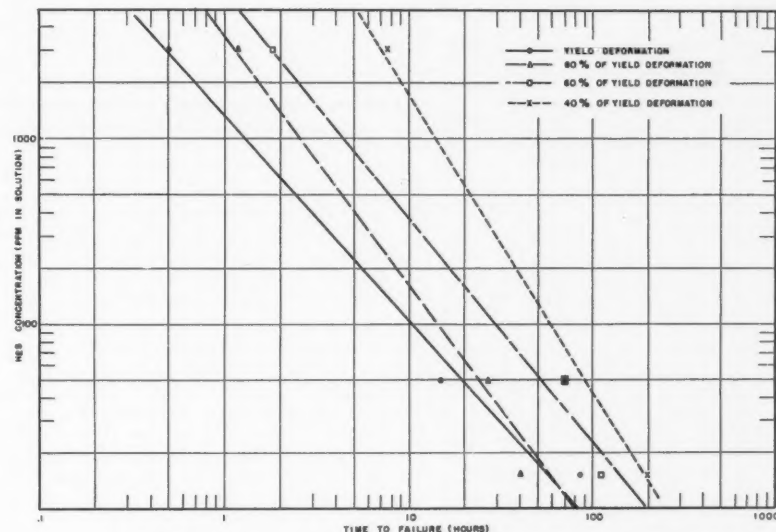
Figure 7—Time-to-failure data shown in Figure 4 plotted versus  $\text{H}_2\text{S}$  concentration.

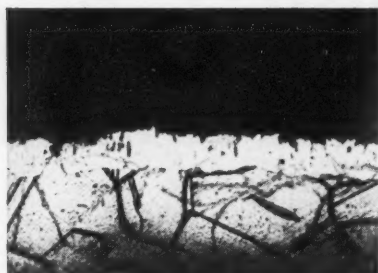
Figure 3—Unidentified phase found between steel and slag in tube containing 34 percent  $V_2O_5$  + 66 percent  $NaVO_3$ ; heated to 1300 F. Etched electrolytically in 10 percent oxalic acid. 335X.

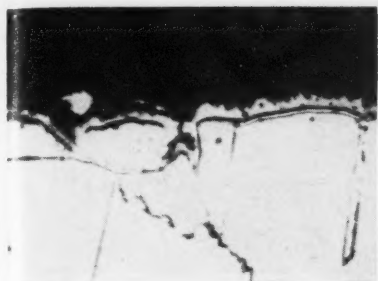
Figure 5—Unidentified phase surrounding a crystal of steel in tube containing 100 percent  $V_2O_5$  with moist air atmosphere heated to 1890 F. Etched electrolytically in 10 percent oxalic acid. 500X.

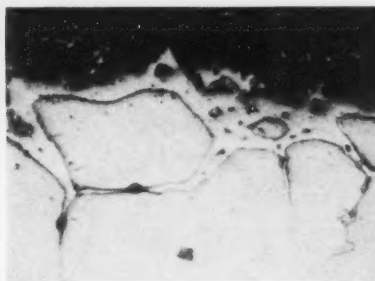
Figure 6—Unidentified phase surrounding several crystals and penetrating along grain boundaries in Type 302 stainless steel. Etched electrolytically in 30 ml  $HNO_3$  + 20 ml acetic acid. 335X.

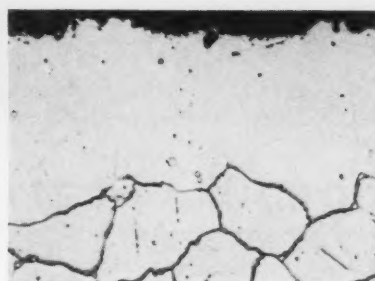
Figure 7—Nodules, most probably of a second unidentified phase, at grain boundaries. Etchant 30 ml  $HNO_3$  + 20 ml acetic acid. 335X.

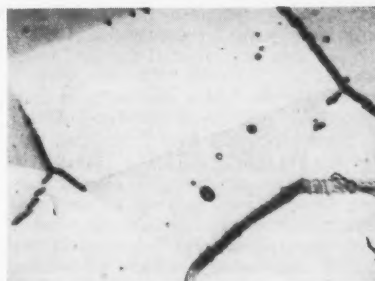
Figure 9—Unusual structures found at grain boundaries of steels heated to 1890 F. Etched electrolytically in 10 percent oxalic acid. 335X.

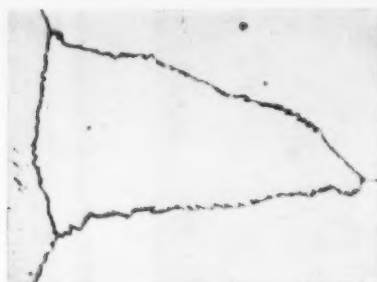
Figure 10—Structure of same specimen as Figure 9 but etched electrolytically in 10 percent NaCN, showing that complex structure was not due to carbides. 500X.

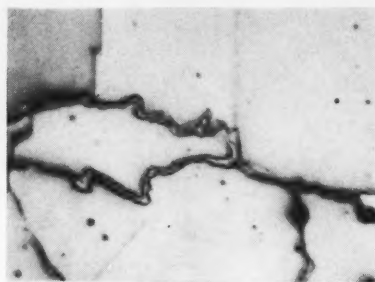
Figure 11—Grain boundary structure of specimen heated to 2090 F in  $\text{NaVO}_3$  and moist air. Etched electrolytically in 30 ml  $\text{HNO}_3$  + 20 ml acetic acid. 500X.

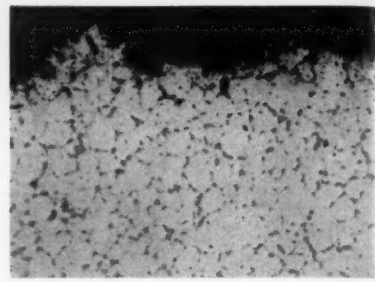
Figure 12—Structure of piece of tubing completely immersed in  $\text{V}_2\text{O}_5$  at 1870 F with a moist air atmosphere. Note the intercrystalline penetration or agglomeration of an unidentified phase at the grain boundaries. Unetched. 335X.

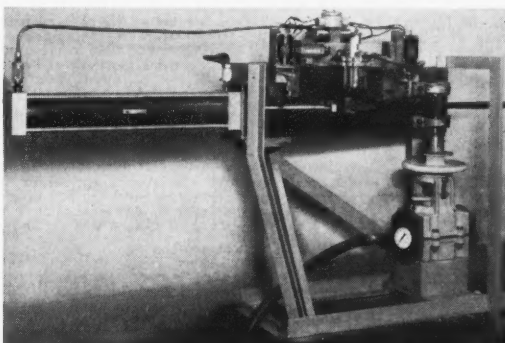
Photo shows test equipment for opening and closing valve to simulate years of actual plant operation. This set-up provided checks on the wearing qualities of spindle threads, sealing qualities of the "Teflon" plastic to carbon seat, and the leak-proof operation of spindle packings.

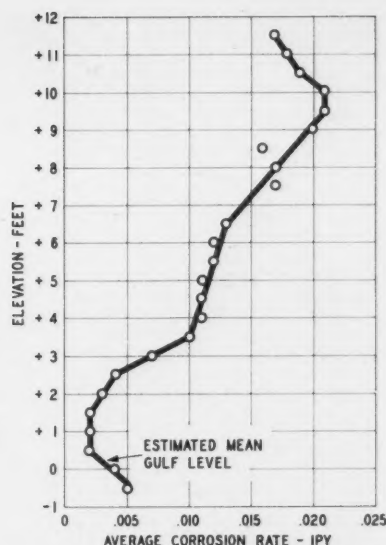
Figure 1—Corrosion graph showing relation of corrosion rate of 24-inch carbon steel conductor pipe exposed on an offshore platform in the Gulf of Mexico.
